# Manhole Inspection Summary

Manhole # S17AA2018MH

Insp Date: **11/13/06 1:39 PM**

**Location** Address: **1814 GREENBERRY RD**

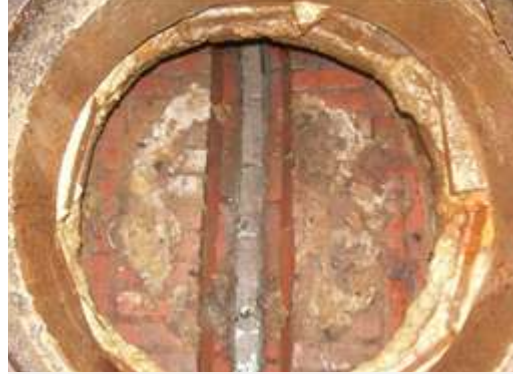
Top View

☒ **Debris** (not Condition related)

☒ **Evidence Of Surcharge**

Evidence of surcharge - Bench debris.

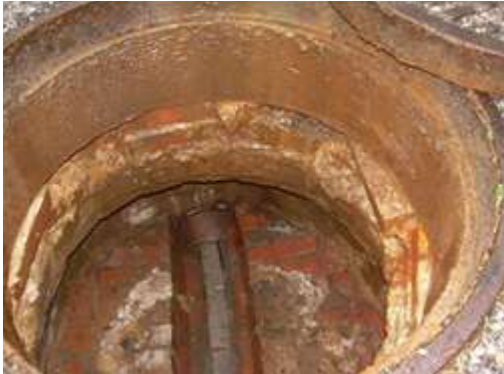
Defect

☒ **Leaks**

Condition: ☐ Sound ☐ Cracked ☐ Root Intrusion ☒ **Loose Brick** ☒ **Deteriorated**

Infiltration: ☐ None ☒ **Joint** ☐ Cracks ☒ **Mortar** ☐ Roots ☐ Wall

Infiltration: ☐ None ☐ Joint ☐ Cracks ☒ **Mortar** ☐ Roots ☒ **Wall**

Frame leaks. Adjustment loose brick, deterioration and infiltration. Barrel infiltration.

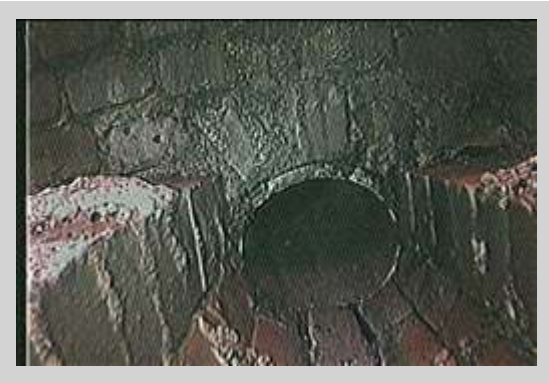
### 8 in. Circular Gravity Sewer Pipe Out @ 12 O'Clock

Barrel deterioration and infiltration. Channel deterioration.

Infiltration: **Evidence** Pipe Seal Cond: **Unknown**

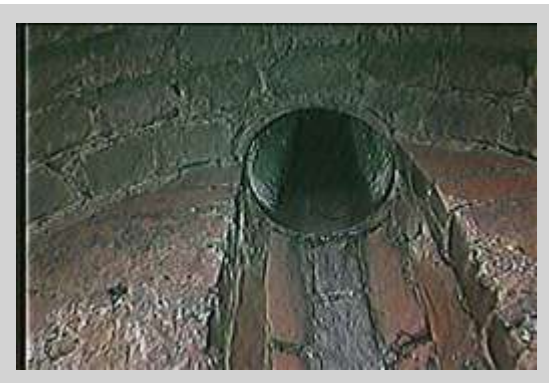
### 8 in. Circular Gravity Sewer Pipe In @ 6 O'Clock

Channel deterioration.

Deposits: ☐ None ☐ Mud ☐ Sludge ☐ Debris ☒ Grease

Infiltration: **Evidence** Pipe Seal Cond: **Unknown**
